INSPECTION REPORT
123 Property
LaGrange, Georgia 30240

Inspection Date	Mar 3, 2023
Company	Lucky U Inspections, LLC
Inspector	Brandon Puckett
Client	Client Name

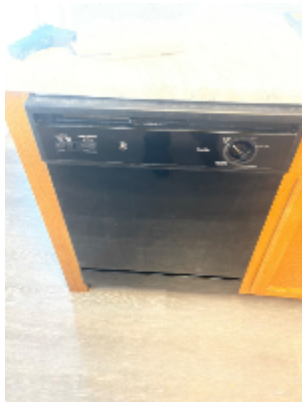
Dishwasher was not working at the time of the inspection, have repaired or replaced by a qualified professional.

Dishwasher door would not latch nor would the dishwasher turn on, have repaired or replaced by a qualified

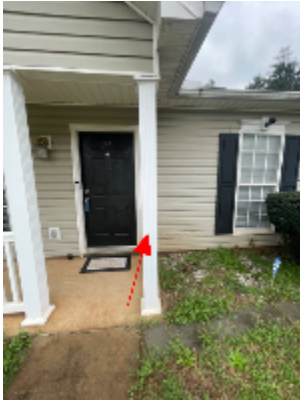
The right side column is loose on the front porch, have repaired or replaced by a qualified professional.

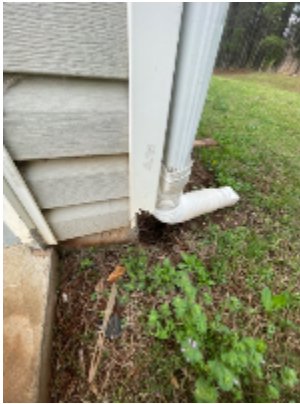
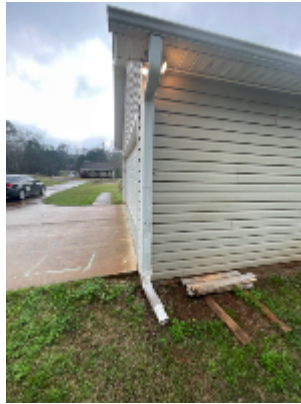
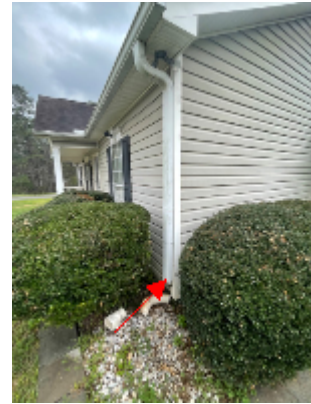
Multiple downspouts missing elbows and block splash have them replaced or repaired by a qualified professional.

Downspouts are not connected and are missing block splash, have repaired or replaced by a qualified

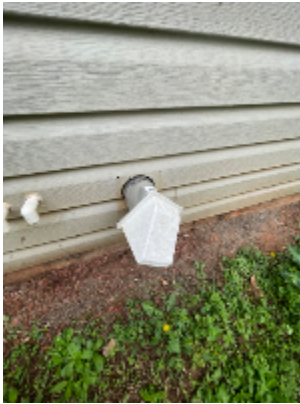
Dryer exhaust vent is not connected to the exterior of the home, have repaired or replaced by a qualified professional.

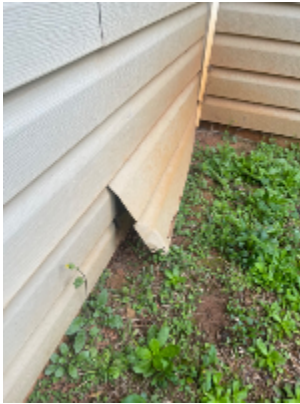
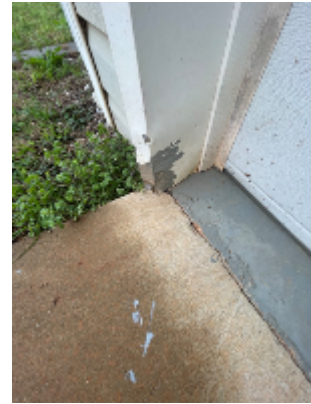
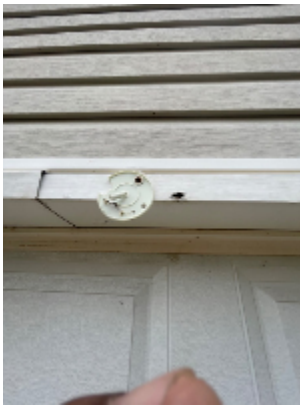
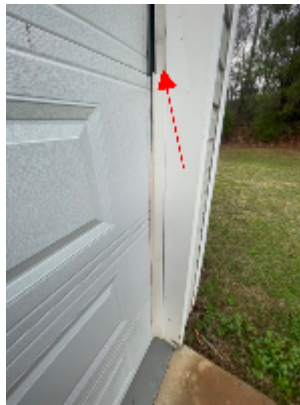
Multiple damaged spots on the siding of the home, have repaired and replaced by a qualified professional.

siding near garage door opening is damaged, have repaired or replaced by a qualified

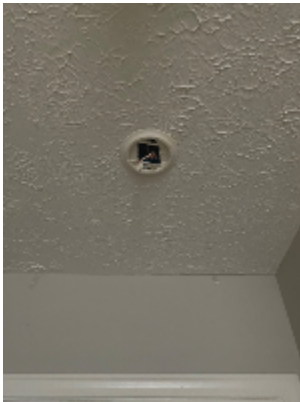
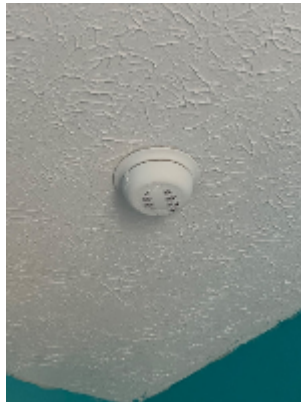
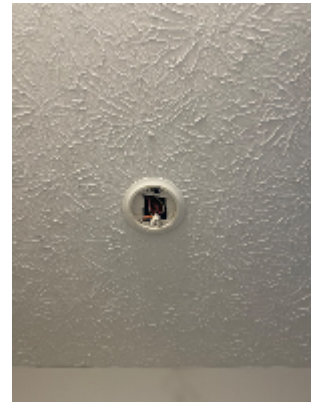
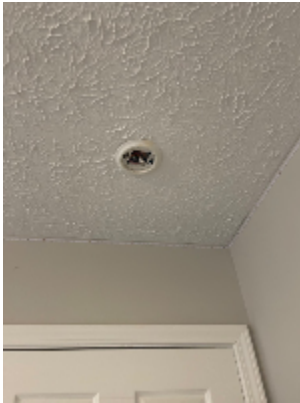
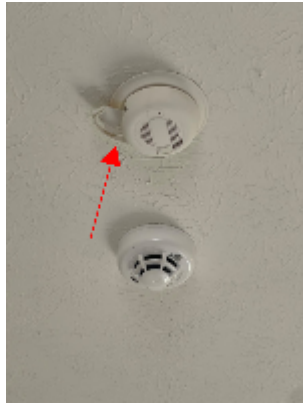
Missing

Without one, high levels of carbon monoxide cannot be detected

Multiple CO alarms or smoke detectors missing throughout home, have installed or repaired by a qualified professional.

Install a carbon monoxide detector

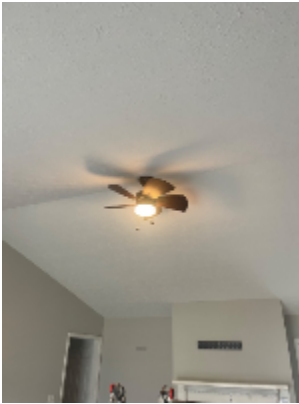
The living room ceiling fan is not working, have repaired or replaced by a qualified profesional.

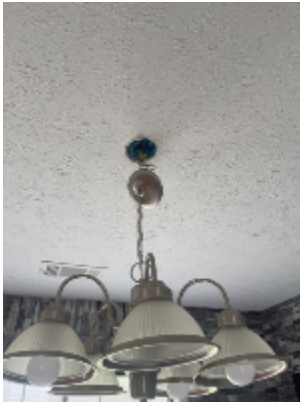
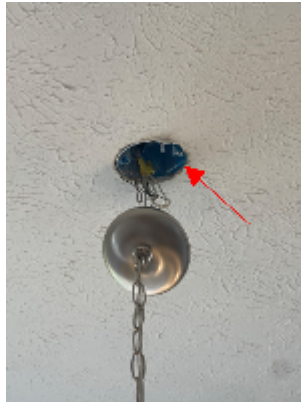
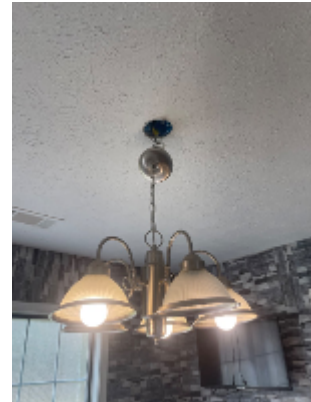
Dining room light fixture is unstable and the light cover is not secure, have repaired or replaced by a qualified professional.

Have cover and light placed back in the correct position.

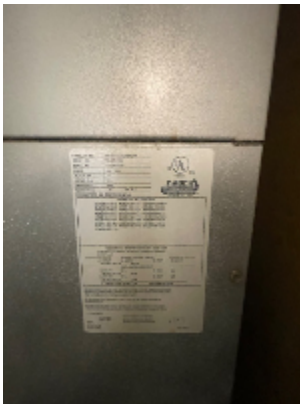
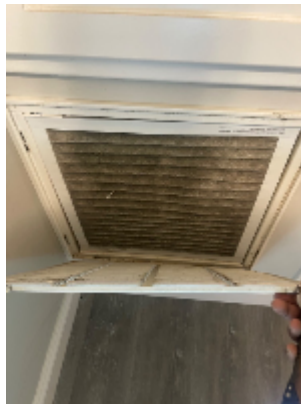
Air conditioner filter door lock is broken on the (left side), have repaired or replaced by a qualified professional.

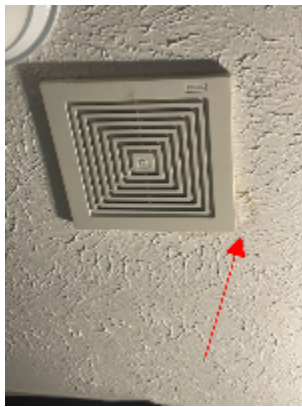
Excessively noisy beyond its normal operation

The noise may indicate the exhaust fan is failing

Guest bathroom exhaust is noisy have repaired or replaced by a qualified

Repair or replace the cause of the noise

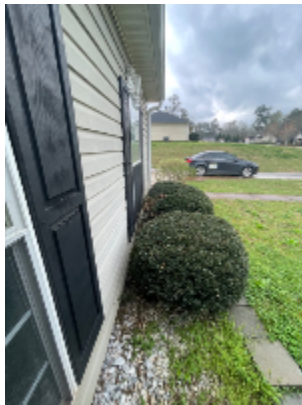
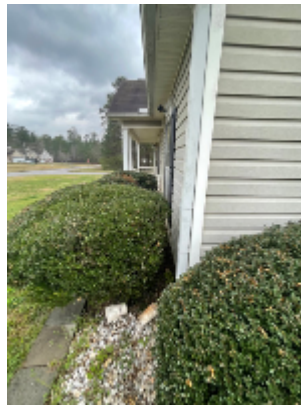
Shrubbery is in contact with home or siding

The shrubbery provides an environment where moisture and/or insects could intrude

Regularly trimm the shrubbery to achieve a clearance of at least 6 - 8 feet

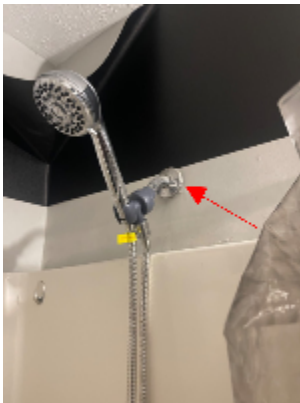
Showerheads are unstable, have resecured or replaced as needed by a qualified professional

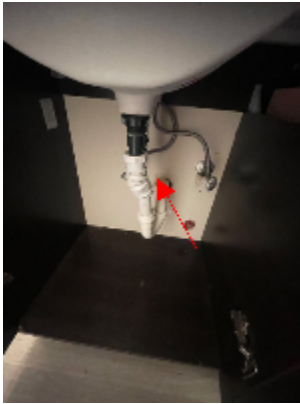
Master bath sink has a flex drain pipe, have replaced by a qualified professional.

Flex drain pipes have a tendency to clog at a much greater rate than a smooth-walled pipe. plumbing standards today require a smooth-walled pipe capable of self-cleaning to be used for sink drains and waste pipes.

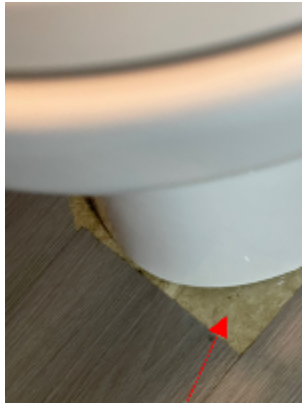
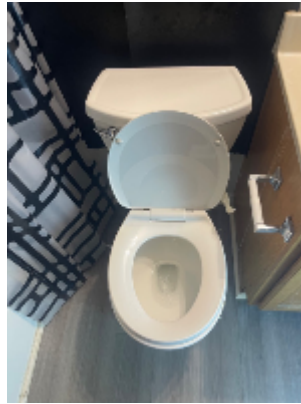
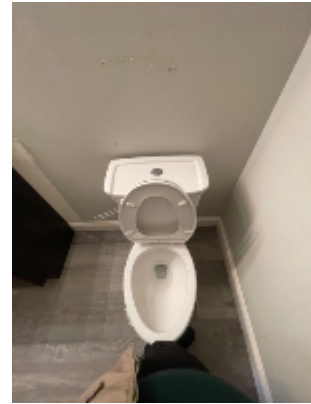
Toilets are unstable, have all toilets secured by a qualified professional.

Guest bathroom toilet is very unstable, the toilet is also leaking, have repaired or replaced by a qualified professional.

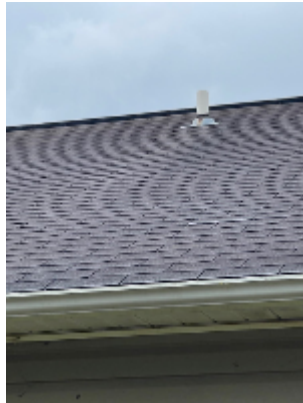
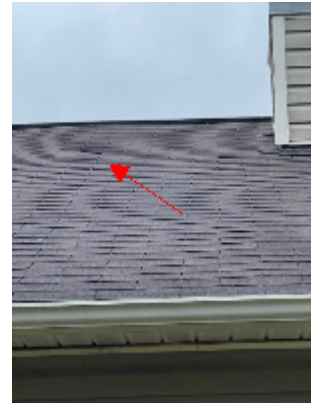
Roofing is starting to show age. There were no torn shingles found. No signs of water intrusion found at the time of the inspection.

Multiple shingles are starting to uplift, none were torn at the time of the inspection.

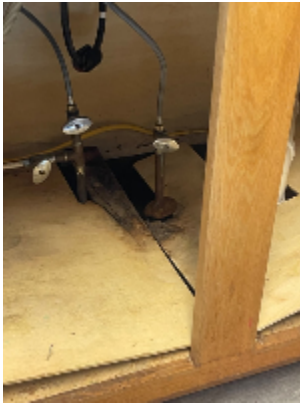
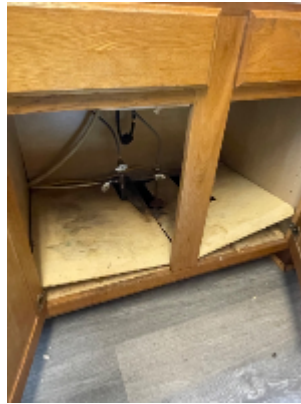
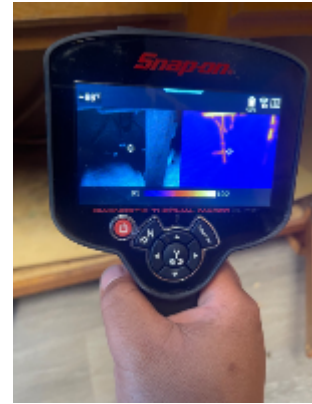
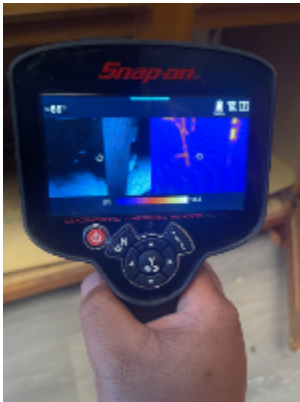
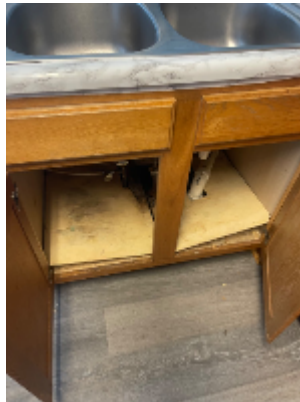
The Kitchen cabinet was damaged due to water intrusion, have cabinet replaced by a qualified professional.

There was no sign of a water leak at the time of the inspection.

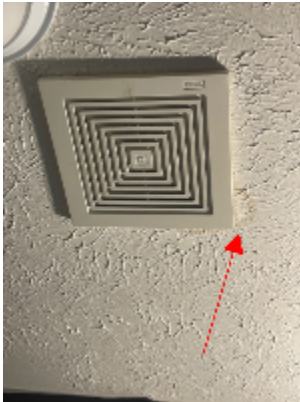
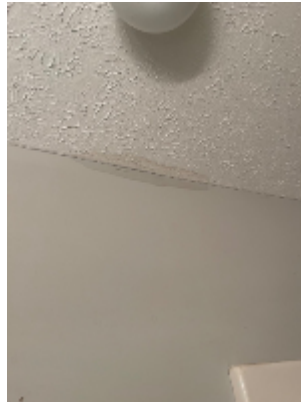
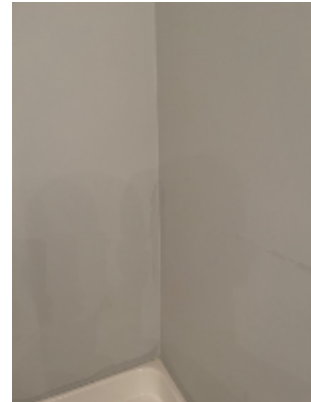
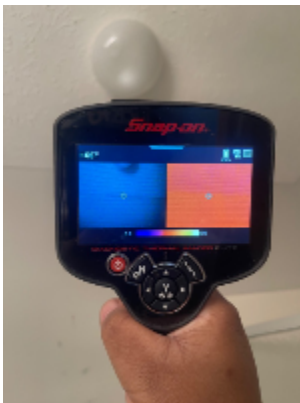
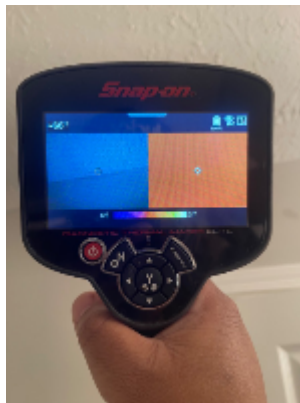
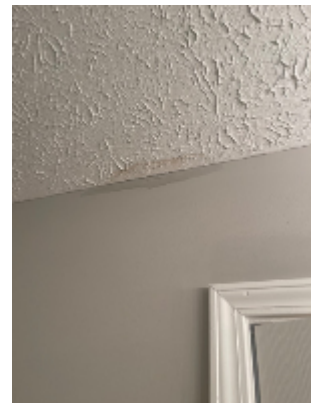
There are multiple signs of water intrusion on the ceiling, no active leaks found the time of the inspection. this is something to monitor.

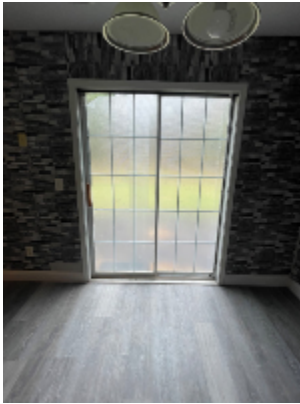
Sliding door leading into the kitchen will not lock nor open properly, have repaired or replaced by a qualified professional.

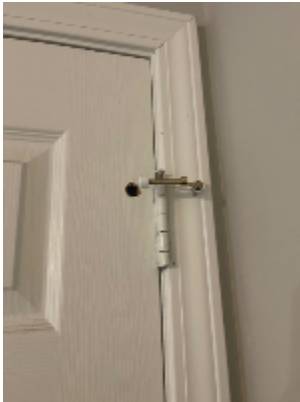
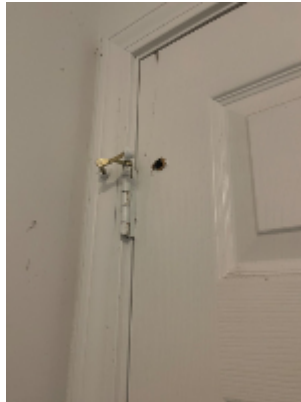
Master bathroom door and laundry room door have small holes from the door stop, have repaired or replaced by a qualified professional.

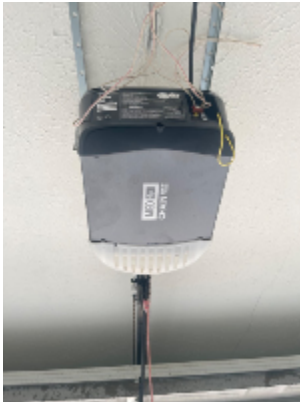
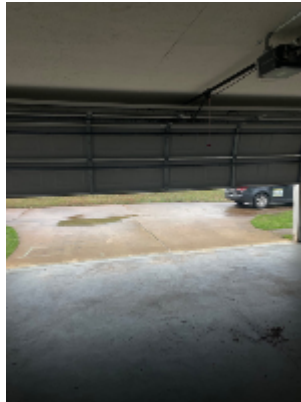
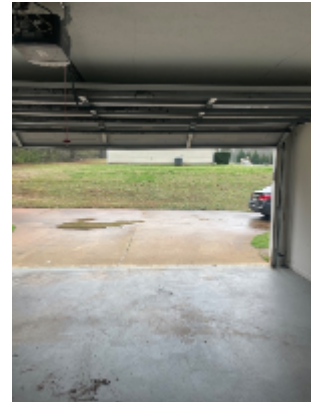
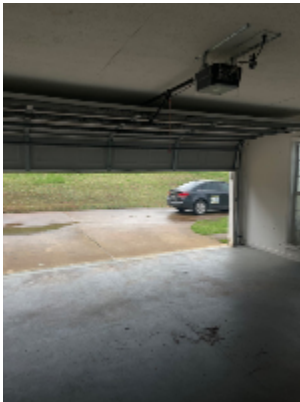
Garage door will open when pressing the garage opener but will not close, have repaired or replaced by a qualified professional.

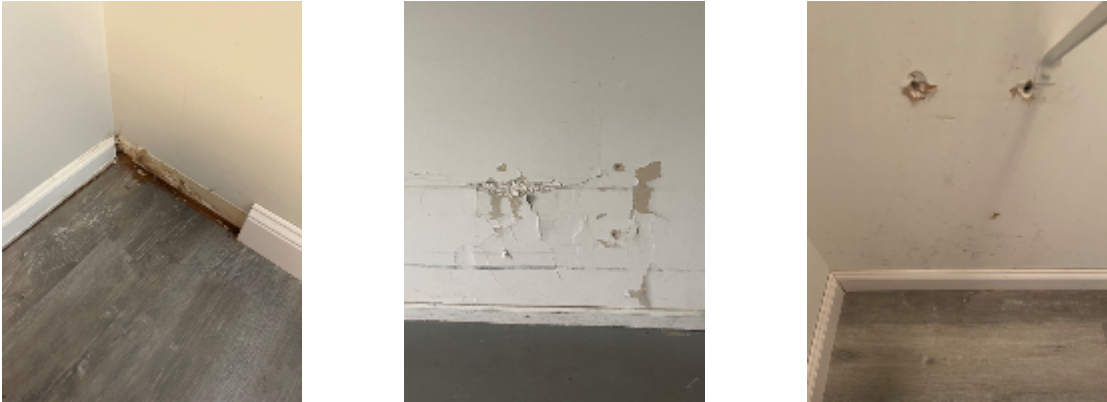
MINOR CONCERN multiple walls have sheetrock damage, have repaired or replaced by a qualified professional.
