INSPECTION REPORT
123 Property
LaGrange, Georgia 30240

Inspection Date	Mar 3, 2023
Company	Lucky U Inspections, LLC
Inspector	Brandon Puckett
Client	Client Name

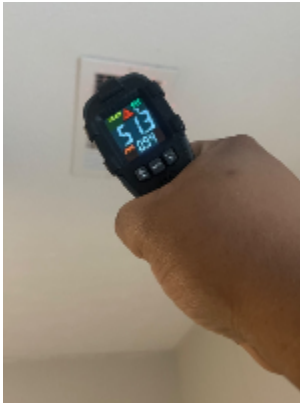
Cold air temp reading

Air flowed properly through HVAC venting at the time of the inspection.
