INSPECTION REPORT
123 Property
LaGrange, Georgia 30240

Inspection Date	Mar 3, 2023
Company	Lucky U Inspections, LLC
Inspector	Brandon Puckett
Client	Client Name

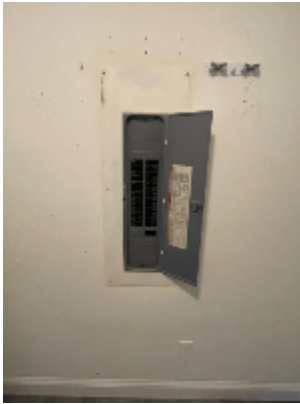
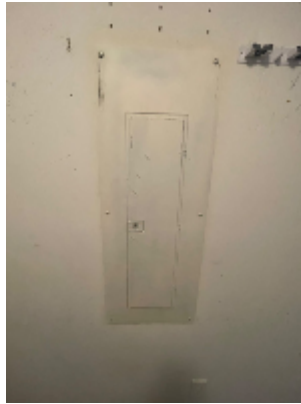
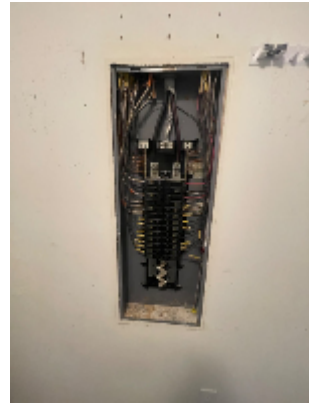
Electrical service panel in working condition at the time of the inspection.

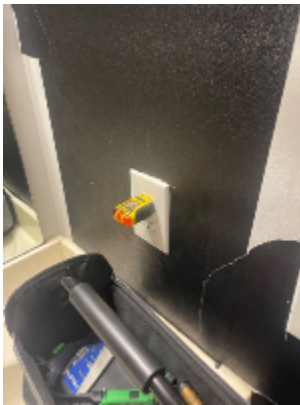
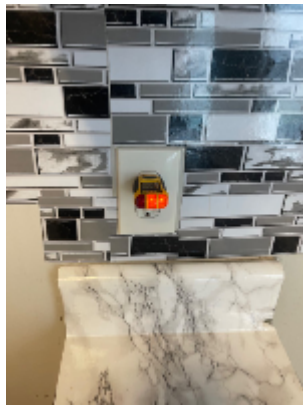
GFCI outlets working properly at the time of the inspection.

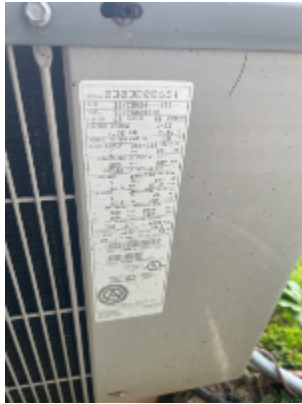
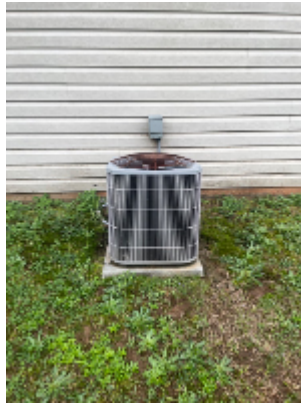
Ac Unit in good condition at the time of the inspection.

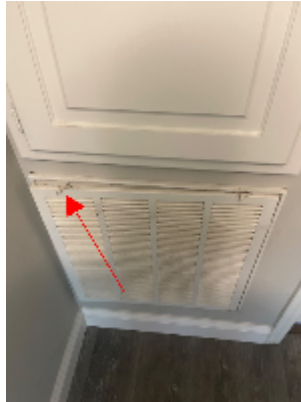
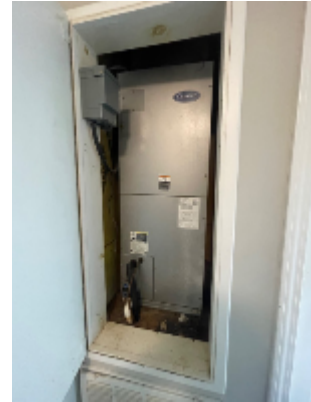
Unit was in good condition at the time of the inspection.

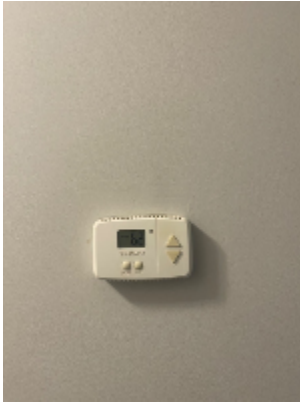
Temperature differential is within 3 degrees

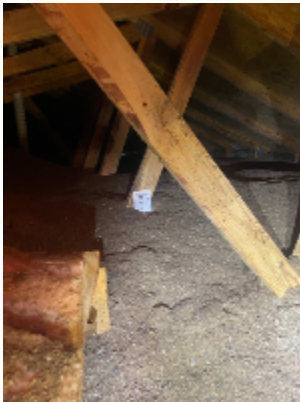
Insulation at the correct height at the time of the inspection.

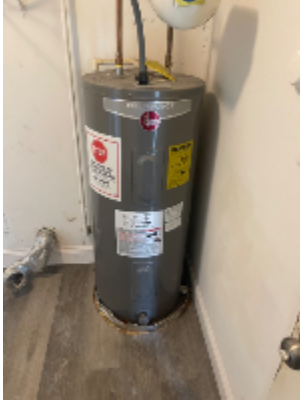
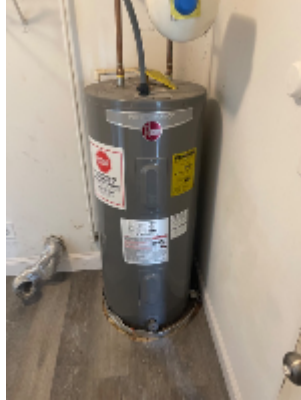
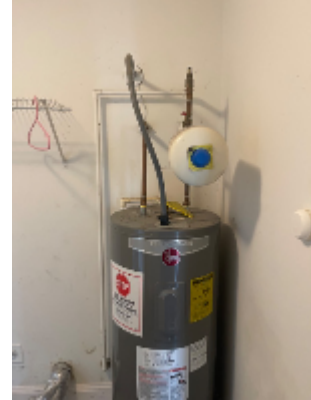
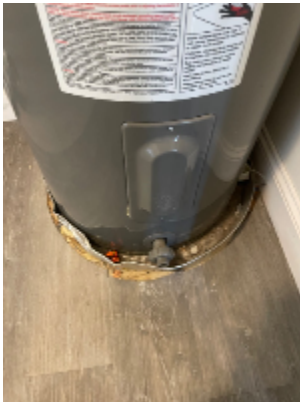
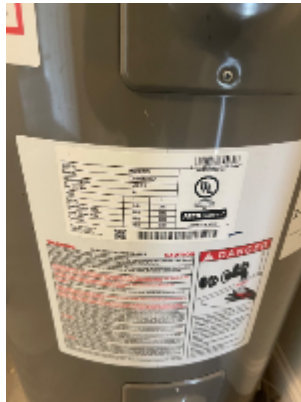
Hot water heater working properly at the time of the inspection.

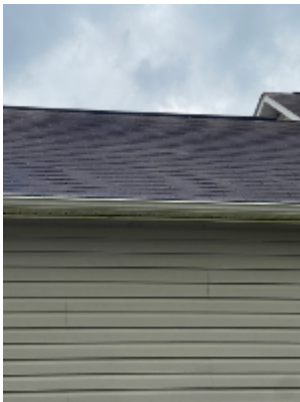
21. **Roof Material:** Roofing is starting to show age. There were no torn shingles found. No signs of water intrusion found at the time of the inspection.
22. **Ceiling:** There are multiple signs of water intrusion on the ceiling, no active leaks found the time of the inspection. this is something to monitor.

Multiple shingles are starting to uplift, none were torn at the time of the inspection.

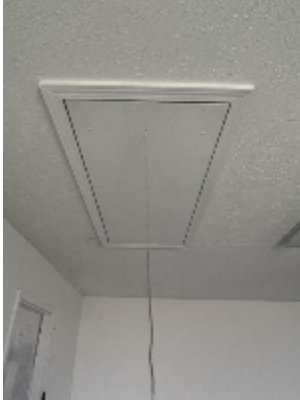
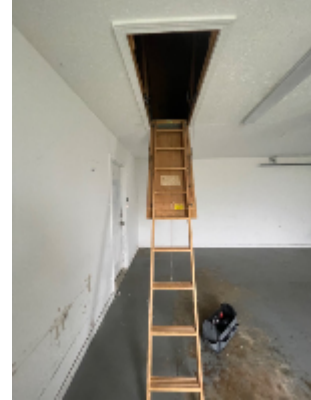
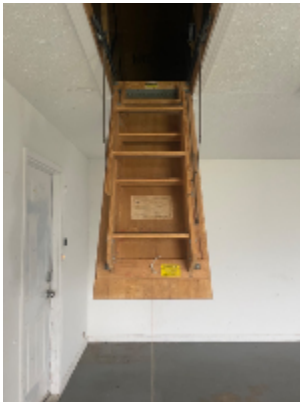
Attic entry in good condition at the time of the inspection.
